# Manhole Inspection Summary

Manhole # S01CC2022MH

**Location** Address: **3305 Bancroft Rd** Cross Street: **Cross Country Blvd**

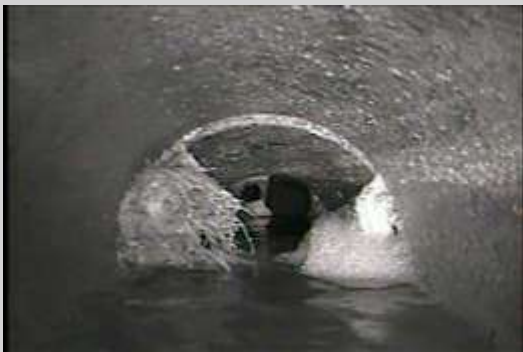
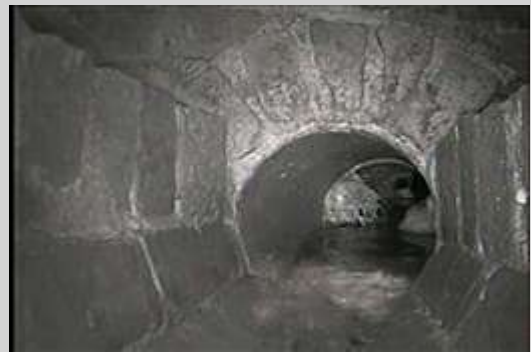
#### Pipe Out @ 12 O'Clock

Pipe Material: **Clay** ☐ Pipe Lined

Invert Depth: **7.80** (ft.) Flow Characteristics: **Fast**

Deposits: ☒ None ☐ Mud ☐ Sludge ☐ Debris ☐ Grease

Infiltration: **None** Pipe Seal Cond: **Sound**

Drop: **None**

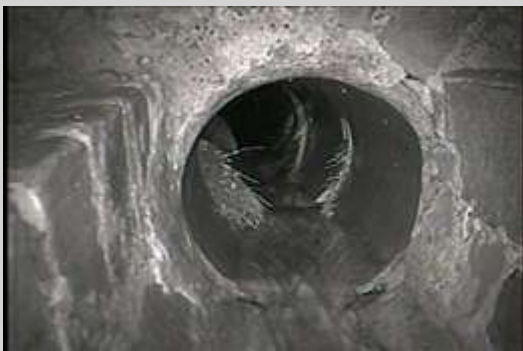
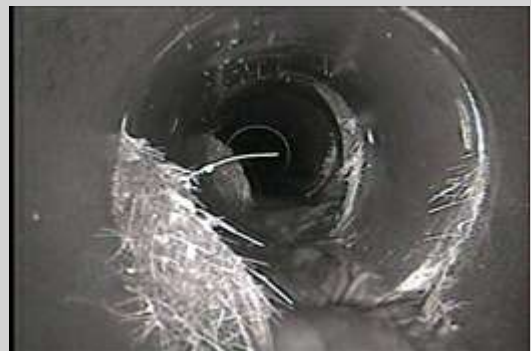
#### Pipe In @ 5 O'Clock

Pipe Material: **Clay** ☐ Pipe Lined

Invert Depth: **7.23** (ft.) Flow Characteristics: **Fast**

Deposits: ☒ None ☐ Mud ☐ Sludge ☐ Debris ☐ Grease

Infiltration: **None** Pipe Seal Cond: **Sound**

Drop: **None**
